GROUNDWATER QUALITY ASSESSMENT FOR DRINKING PURPOSE IN SOUTH-EASTERN PART OF PANCHKULA CITY, HARYANA, INDIA

Abstract

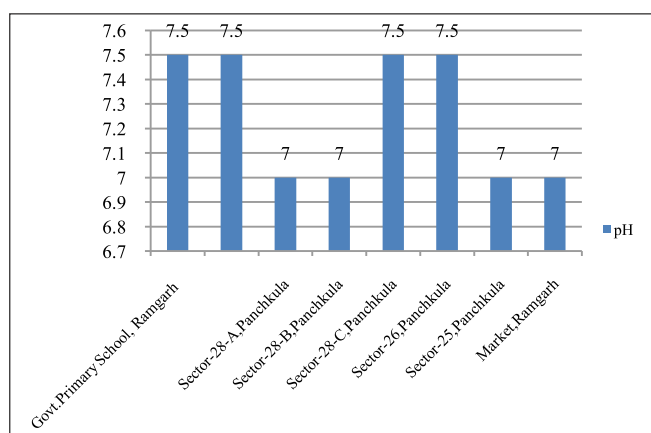
In the study area, pH varied from 7 to 7.5 and desirable in all eight groundwater samples (Fig.2).

Figure 2:pH in groundwater samples.

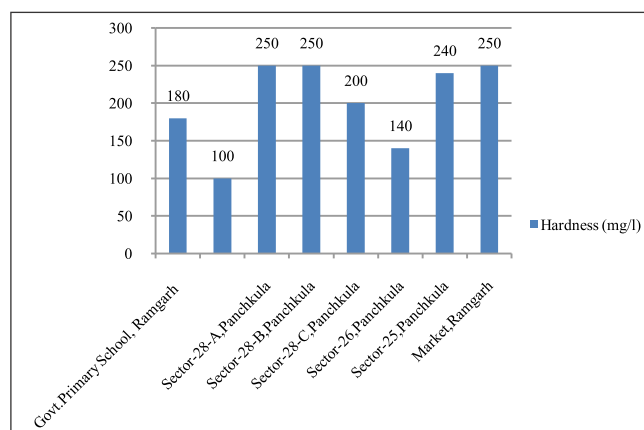
Hardness varied from 100 mg/l to 250 mg/l in the study area. Hardness in groundwater samples was desirable at Govt. Primary School Ramgarh (180 mg/l), Govt. Senior Secondary School Ramgarh (100 mg/l), Sector-28-C, Panchkula (200 mg/l), Sector-26, Panchkula (140 mg/l) and

permissible at Sector-28-A, Panchkula (250 mg/l), Sector-28-B, Panchkula (250 mg/l), Sector-25 (240 mg/l) and Market Ramgarh (250 mg/l) (Fig.3).

Figure 3: Hardness in groundwater samples.

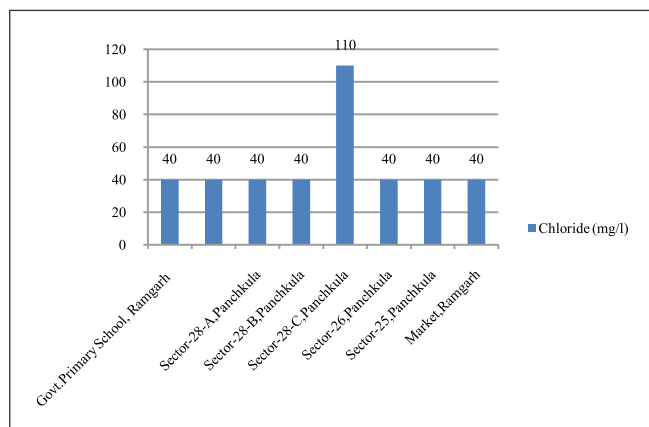
Chloride was present in range from 40 mg/l to 110 mg/l in the study area. Chloride in groundwater samples was within desired limits in all eight groundwater samples (Fig. 4).

Figure 4: Chloride in groundwater samples.

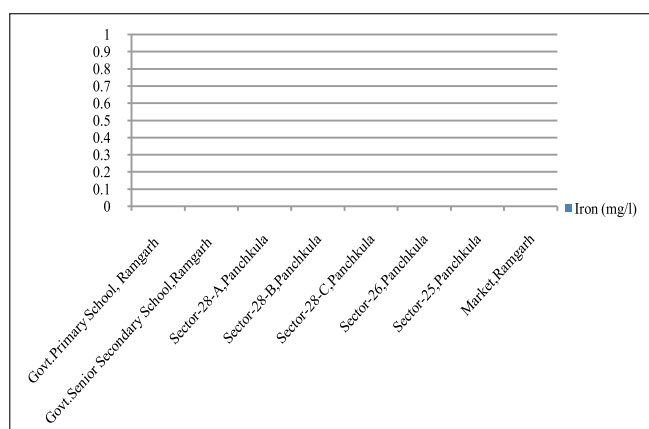
Iron was absent in all eight groundwater samples, hence, desirable for drinking purpose (Fig.6).

Figure 6: Iron in groundwater samples.

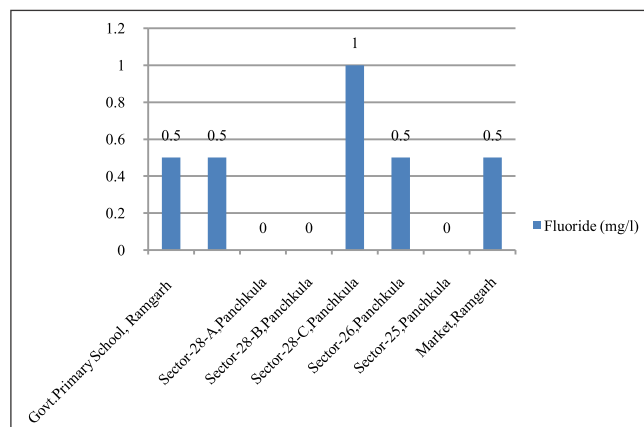
Fluoride had values from 0.5mg/l to 1mg/l in the study area, thus being within desirable limits in all eight groundwater samples (Fig. 5).

Figure 5: Fluoride in groundwater samples.

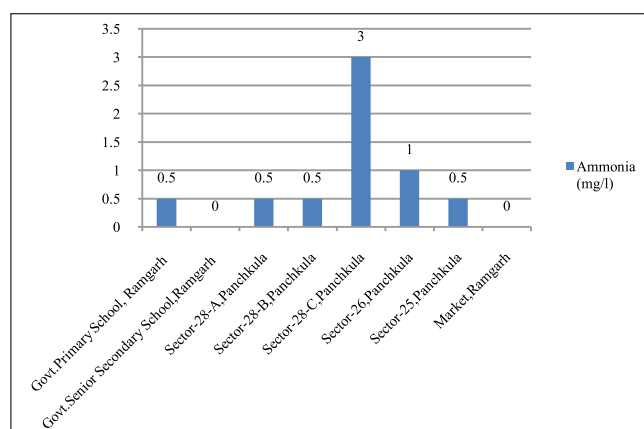
Ammonia varied over nil to 3 mg/l in the study area. Ammonia was in prescribed values at Govt. Primary School,

Ramgarh (0.5 mg/l), Govt. Senior Secondary School Ramgarh (0.0 mg/l), Sector- 28-A, Panchkula (0.5 mg/l), Sector- 28-B, Panchkula (0.5 mg/l), Sector- 25, Panchkula (0.5 mg/l), Market Ramgarh (0.0 mg/l) and non-potable at Sector-28-C, Panchkula (3.0 mg/l) and Sector-26, Panchkula (1 mg/l) (Fig.7).

Figure 7: Ammonia in groundwater samples.

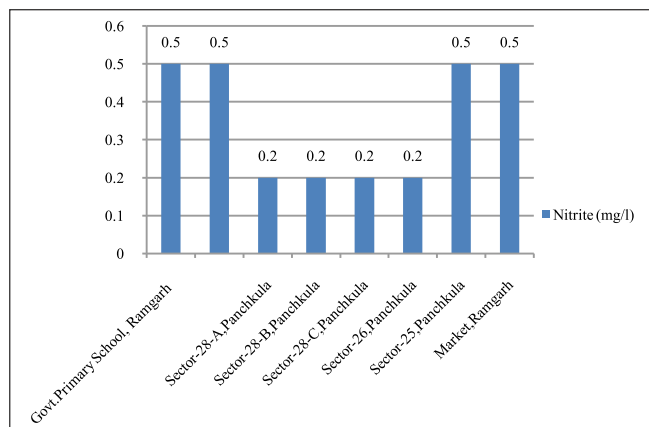
Nitrite varied from 0.2 mg/l to 0.5 mg/l in the study area, desirable for drinking purpose in all eight groundwater samples (Fig.8).

Figure 8: Nitrite in groundwater samples.

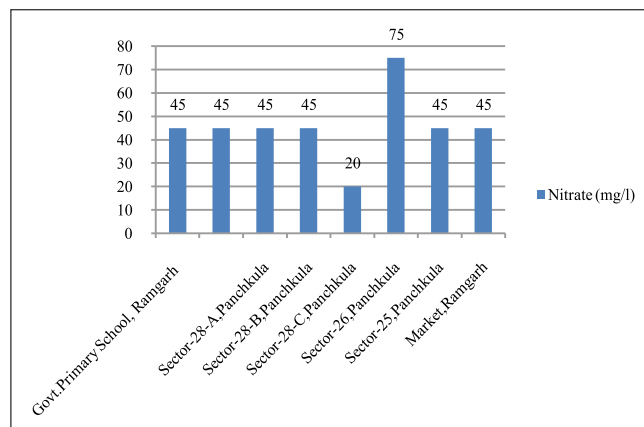
Nitrate varies from 20 mg/l to 75 mg/l in the study area, desirable in seven groundwater samples and non-potable in Sector-26 (75 mg/l) groundwater sample (Fig.9).

Figure 9: Nitrate in groundwater samples.

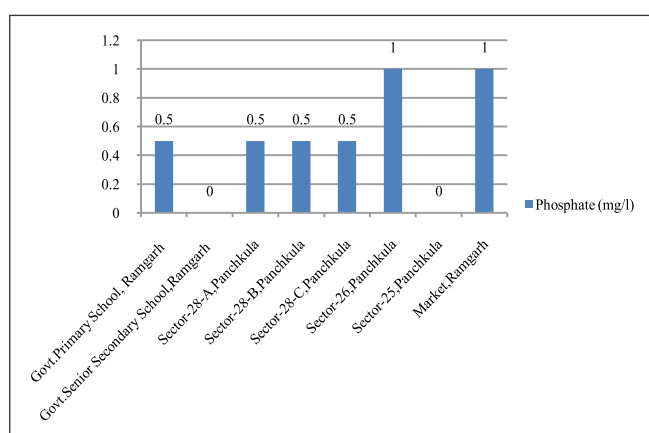
Phosphate was present over nil to 1mg/l in the study area, thus at desirable values in all eight groundwater samples (Fig.10).

Figure 10: Phosphate in groundwater samples.

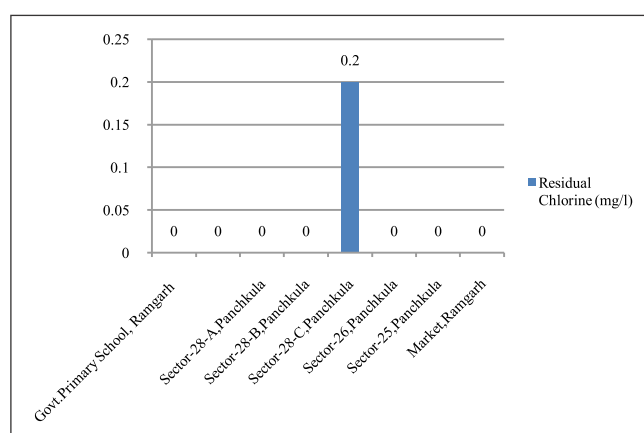
Residual Chlorine had values from nil to 0.2 mg/l in the study area (desirable) (Fig.11).

Figure 11: Residual Chlorine in groundwater samples.

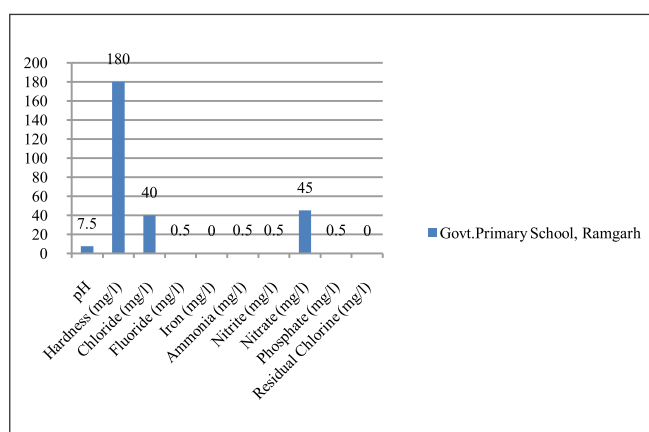
In groundwater sample collected at Govt. Primary School, Ramgarh, the various chemical drinking water parameters studied were found to be within desirable limits (Fig.12).

Figure 12: Groundwater quality at Govt. Primary School, Ramgarh.

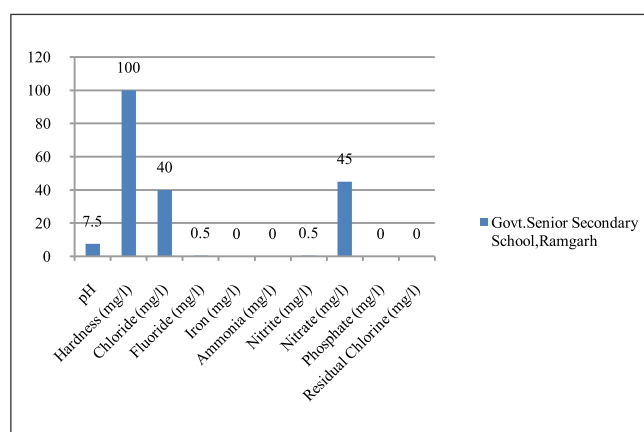
In groundwater sample collected at Govt. Senior Secondary School, Ramgarh chemical drinking water parameters were in desirable limits (Fig.13).

Fig.13: Groundwater quality at Govt. Senior Secondary School, Ramgarh

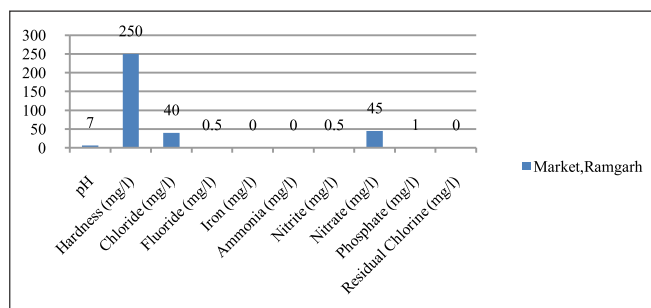
In groundwater sample collected at Market Ramgarh analyzed chemical drinking water parameters pH, chloride, fluoride, iron, ammonia, nitrite, nitrate, phosphate, residual

chlorine were in values as permissible for drinking water (Fig.14).

Figure 14: Groundwater quality at Market, Ramgarh.

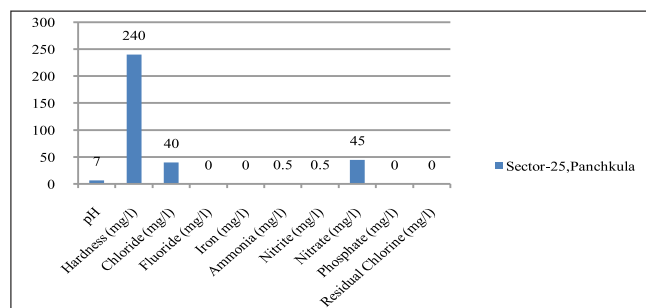
In groundwater sample collected at Sector-25, Panchkula the pH, chloride, fluoride, iron, nitrite, ammonia, nitrate, phosphate, residual chlorine parameters adhered to permissible drinking water limits (Fig.15).

Figure 15: Groundwater quality at Sector-25, Panchkula.

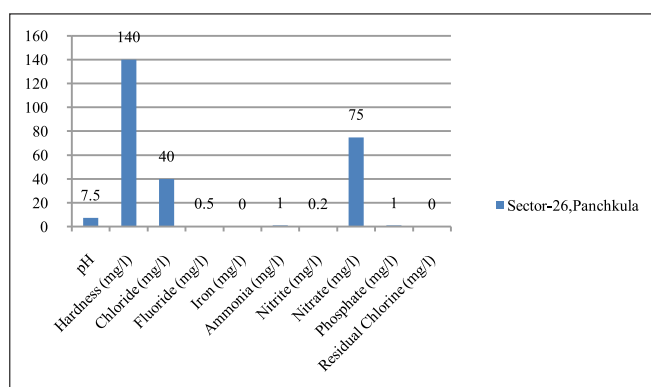
In groundwater sample collected at Sector-26, Panchkula the chemical drinking water parameters were under limited to desirable values and ammonia, nitrate were proper for non-potable drinking water (Fig.16).

Figure 16: Groundwater quality at Sector-26, Panchkula.

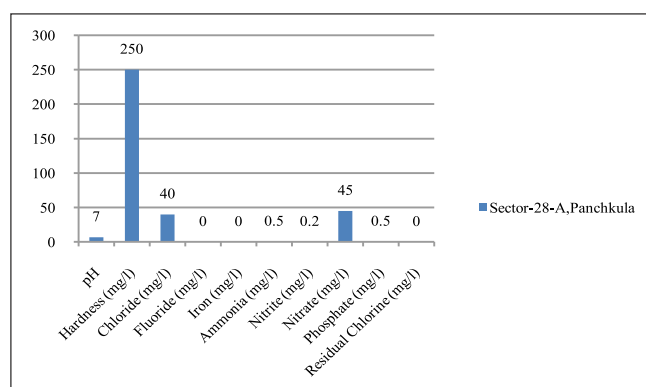
In groundwater sample collected at Sector-28-A, Panchkula the different drinking water parameters were found to be

Figure 17: Groundwater quality at Sector-28-A, Panchkula.

desirable and hardness was permissible for drinking water purposes (Fig.17).

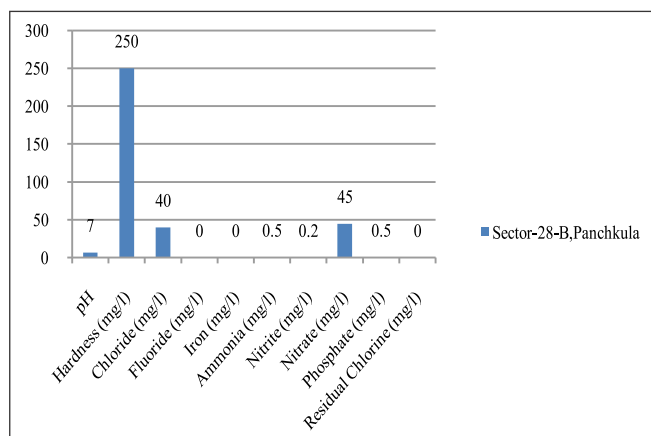
In groundwater sample collected at Sector-28-B, Panchkula, the chemical drinking water parameters pH, chloride, fluoride, iron, ammonia, nitrite, nitrate, phosphate, residual chlorine were found to be within desirable limit and hardness under permissible drinking water limit (Fig.18).

Figure 18: Groundwater quality at Sector-28-B, Panchkula.

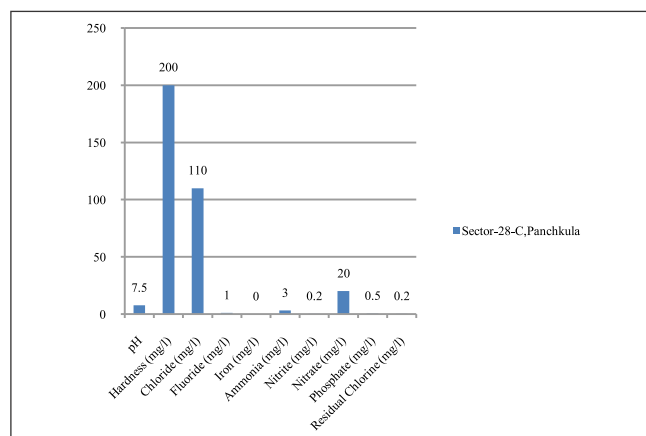
In groundwater sample collected at Sector-28-C, Panchkula, the drinking water parameters analyzed viz. pH, hardness, chloride, fluoride, iron, ammonia, nitrite, nitrate, phosphate, residual chlorine were under desirable limit (Fig.19).

Figure 19: Groundwater quality at Sector-28-C, Panchkula.
